Ivan ad Hercules: una reazione positiva ad un evento negativo

Ivan in Hercules: a positive reaction to a negative event

Joe Pospisil,
Buzzi Unicem USA

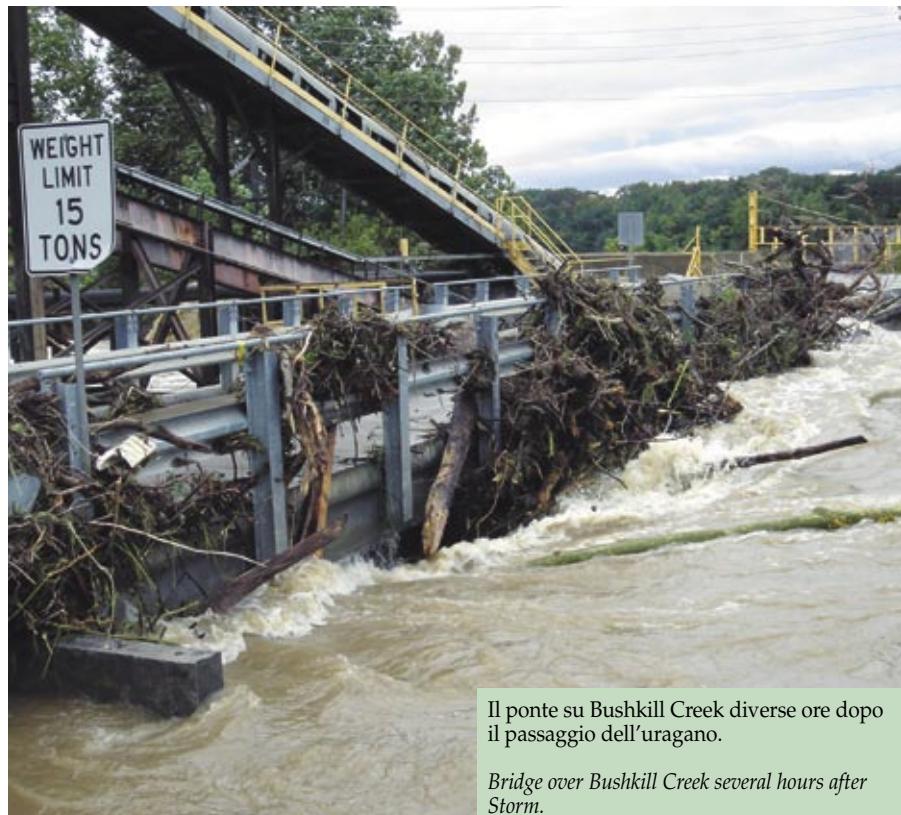
Il ponte su Bushkill Creek diverse ore dopo il passaggio dell'uragano.

Bridge over Bushkill Creek several hours after Storm.

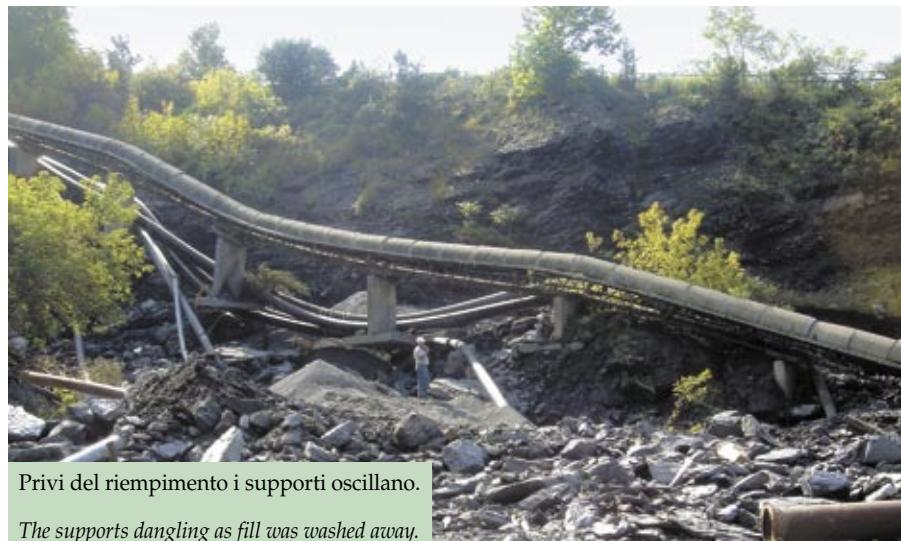
ferito ma alcune auto parcheggiate e le attrezzature dello stabilimento hanno riportato gravi danni. Il Bushkill Creek ha infranto la banchina della cava, formando un'enorme cascata d'acqua che è fuoriuscita dalla diga del bacino orientale. In quel momento, in cava c'era solo una persona - il fatto è avvenuto di sabato mattina - e ha immediatamente trasferito l'attrezzatura mobile più in alto, evitando danni ai mezzi di movimento terra. Il torrente è fluito lungo il percorso del nastro trasportatore, solitamente dedicato a trasferire le pietre dal frantocio primario in cava al frantocio secondario in stabilimento. La portata dell'acqua era così violenta da spazzare via il materiale di riempimento che sosteneva

i basamenti di cava, provocando il crollo del nastro trasportatore. Inoltre, tutte le tubazioni utilizzate per pompare l'acqua fuori dalla cava sono state gravemente danneggiate, impedendone il pompaggio, anche dopo il ripristino dell'elettricità, fino alla riparazione dei danni.

Privi del riempimento i supporti oscillano.

The supports dangling as fill was washed away.

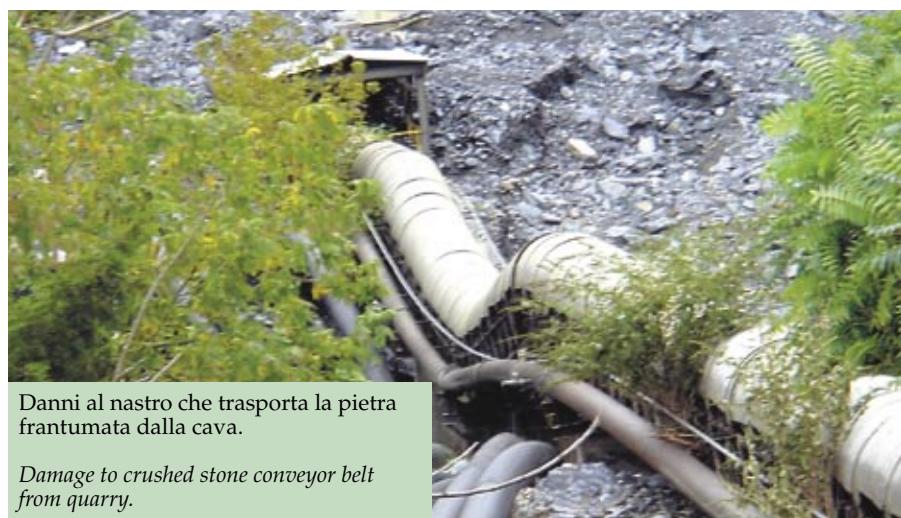
Danni al nastro che trasporta la pietra frantumata dalla cava.

Damage to crushed stone conveyor belt from quarry.
