Ivan ad Hercules: una reazione positiva ad un evento negativo

Ivan in Hercules: a positive reaction to a negative event

Joe Pospisil,
Buzzi Unicem USA

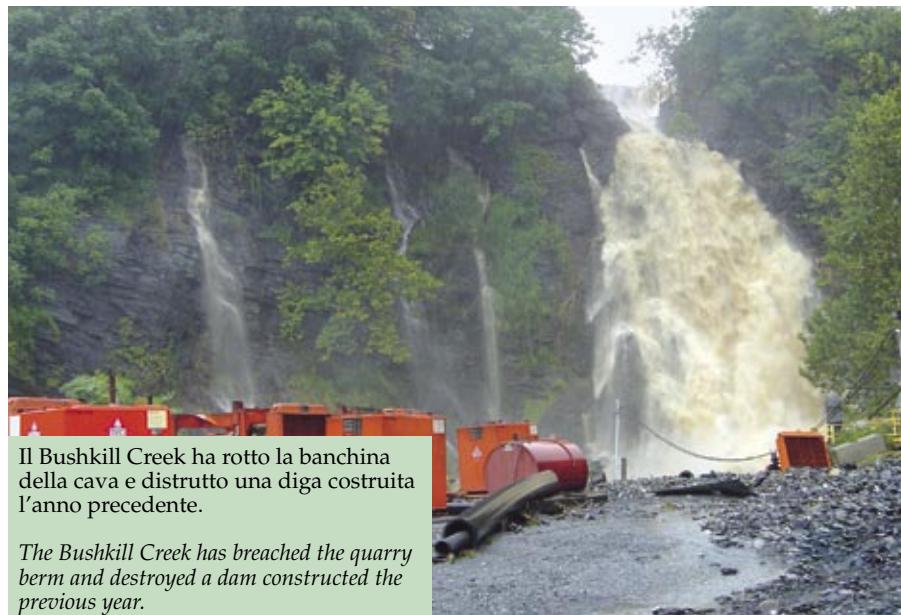
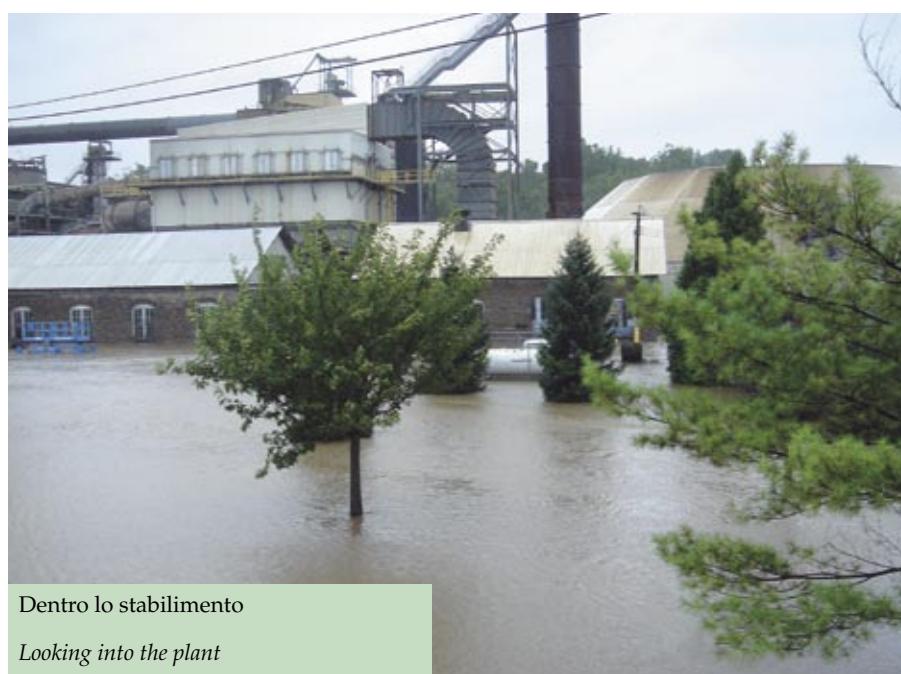
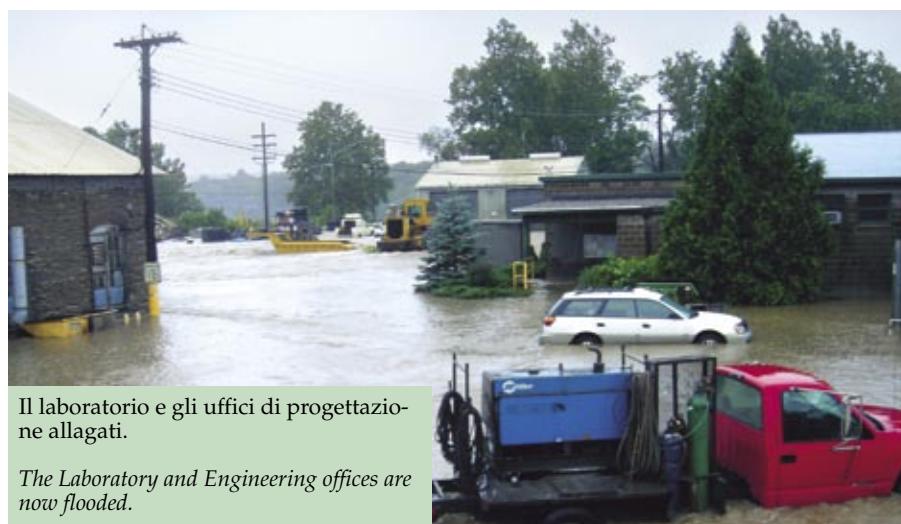
The creek breached the quarry berm and created a gigantic waterfall that blew out the dam in the east sump. Only one person was in the quarry at the time (remember, this was a Saturday morning) and he immediately moved the mobile equipment to high ground thus preventing damage to the haul equipment. The creek flowed down along the track of the belt conveyor used to convey the stone from the primary crusher in the quarry to the secondary crusher in the plant. The flow of water was so severe that it washed out the fill material that supported the foundations for the quarry supports causing the

belt to collapse. Also, all of the piping used to convey the water being pumped from the quarry was badly damaged preventing any pumping once power was restored until the damage could be repaired. This quarry has a major water problem anyway and upwards of 60,000,000 gallons of water per day is pumped. The water started to recede from the plant within a few hours and efforts commenced immediately to get power restored. By 6:00 PM that day an outside electrical contractor was in the plant with men and equipment to start the restoring effort. All underground conduits were flooded and all manholes had to be pumped out. Then, all wiring had to be tested before power could be established. The quarry was a major concern as pumping could not be started until the piping was repaired and the water level was rising. Primary pumping is done with 4 vertical turbine pumps and it was discovered that they had become buried in mud from the creek washing into the quarry. Many portable diesel pumps were brought in, the pipes repaired, and pumping re-established. It was estimated that upwards of 600,000,000 gallons of water needed to be pumped out of the quarry! This was in addition to the normal pumping required. It required over 3 months to pump out the quarry. It is difficult to describe the work necessary to restore the plant. The water and mud penetrated several MCC's and they had to cleaned, be dried out and tested. Over 200 motors had to be pulled and sent out for drying and testing.
